**Flood Control Project Maintenance
Levee Inspections**
LMA District Cover Sheet
Spring 2015 Levee Inspection Results

Reclamation District No. 0765 Glide

Spring 2015 Levee Inspection Results

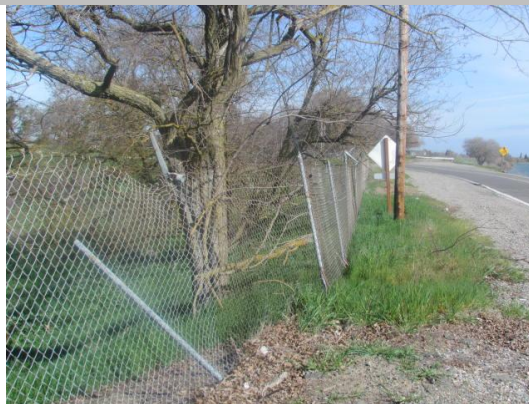
Photo 1 of 1 : SP_2015_RD0765_211_3_20150309_00003.jpg

Looking north (upstream) at trees on landside slope.

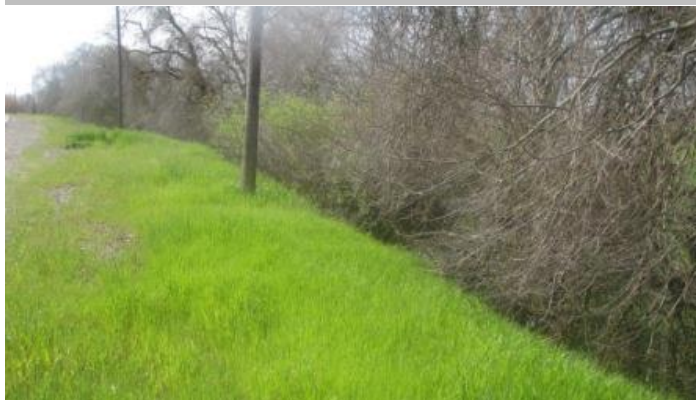
Photo 1 of 2 : SP_2015_RD0765_211_28_20150309_00028.jpg

Looking downstream (south) at trees on landside slope & toe.

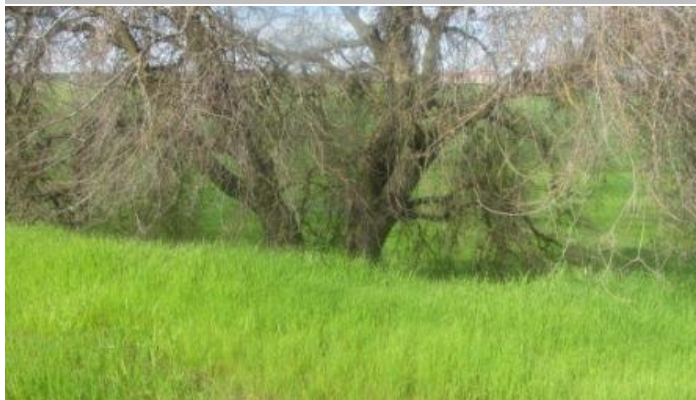
Photo 2 of 2 : SP_2015_RD0765_211_28_20150309_00029.jpg

LM Start	0.12	Rating **	M	Issue No.	28 (cont)
LM End	0.19	Issue Type +	Ma	Location *	LS

Looking west at trees on landside toe.

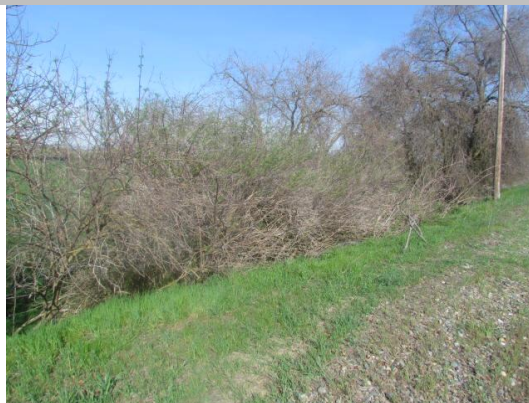
Photo 1 of 1 : SP_2015_RD0765_211_22_20150309_00025.jpg

Looking northwest at dense vegetation on landside slope.

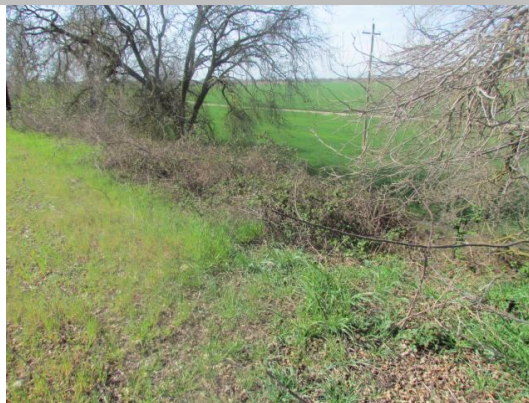
Photo 1 of 1 : SP_2015_RD0765_211_49_20150309_00050.jpg

Looking at wild berryvines or wild roses on landside slope and toe.

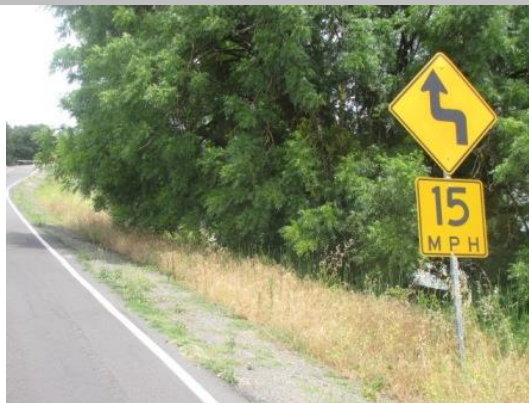
Photo 1 of 5 : SP_2015_RD0765_211_11_20150309_00011.jpg

LM Start	0.25	Rating **	A/W	Issue No.	11
LM End	0.27	Issue Type +	Ma	Location *	WS
Category	Earthen Levee			GPS Latitude/Longitude	
				Start	End
Item	Trim / Thin Trees			38.499405 °	38.499042 °
				-121.560445 °	-121.560430 °
DWR ID	DWR_RD0765_01_s _ 2012_11				
Action/Comments					
Thin trees to allow visibility of the ground and room to flood fight.

Looking northeast at overgrown trees on waterside slope.

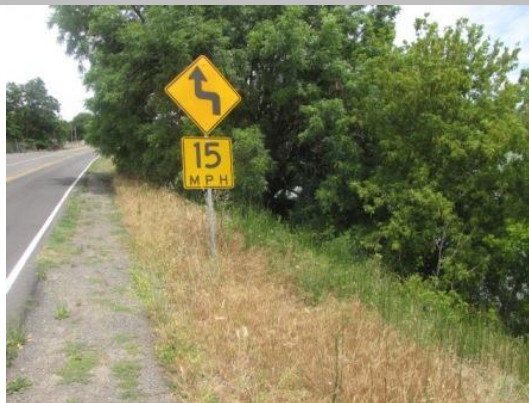
Photo 2 of 5 : SP_2015_RD0765_211_11_20150309_00012.jpg

Looking north at dense trees on waterside slope from fall 2010 inspection.

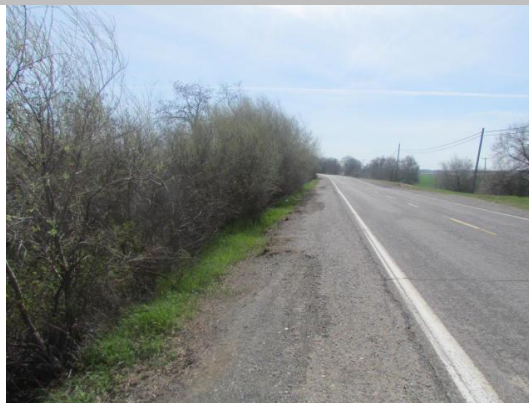
Photo 3 of 5 : SP_2015_RD0765_211_11_20150309_00013.jpg

Looking south (downstream) at dense trees on landside slope and shoulder. (Spring 2013)

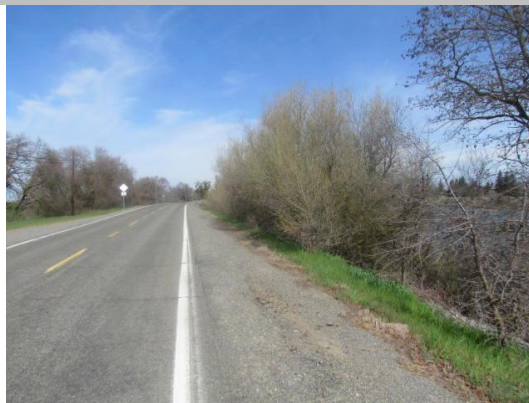
Photo 4 of 5 : SP_2015_RD0765_211_11_20150309_00014.jpg

Looking north (upstream) at dense trees on landside slope and shoulder. (Spring 2013)

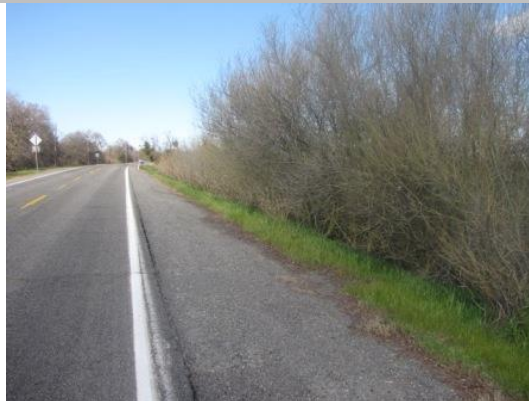
Photo 5 of 5 : SP_2015_RD0765_211_11_20150309_00015.jpg

Looking upstream (north) at dense vegetation and trees from 2011 spring inspection.

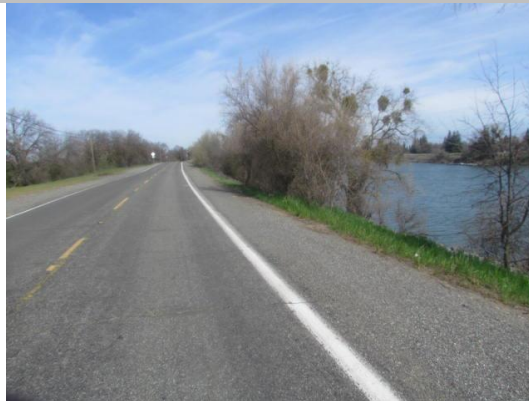
Photo 1 of 1 : SP_2015_RD0765_211_23_20150309_00026.jpg

Looking north (upstream) at untrimmed trees on waterside shoulder and slope.

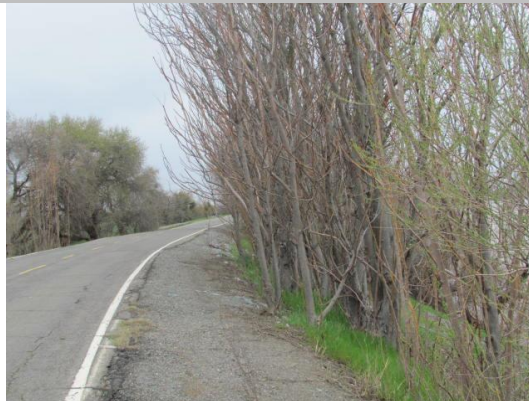
Photo 1 of 1 : SP_2015_RD0765_211_24_20150309_00027.jpg

Looking north (upstream) at untrimmed trees on waterward slope.

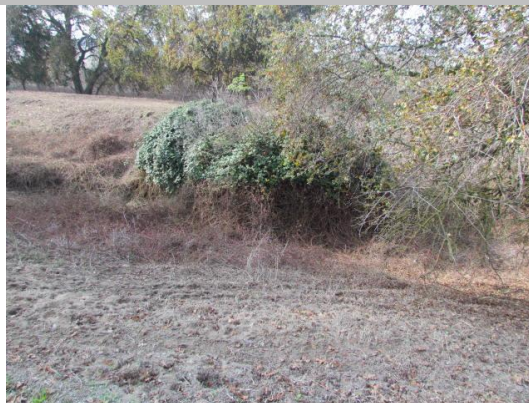
Photo 1 of 1 : SP_2015_RD0765_211_47_20150309_00048.jpg

Looking west at dense berryvines on landside toe.

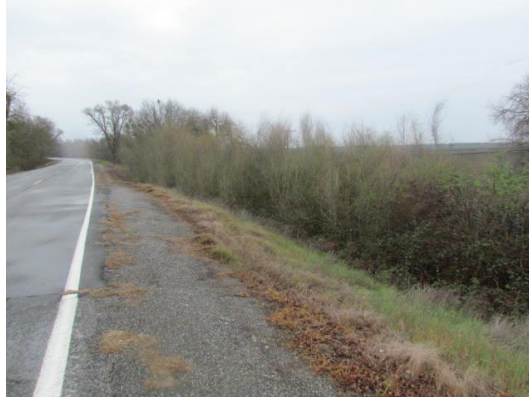
Photo 1 of 1 : SP_2015_RD0765_211_32_20150309_00036.jpg

Looking southwest at dense vegetation on landside slope and toe.

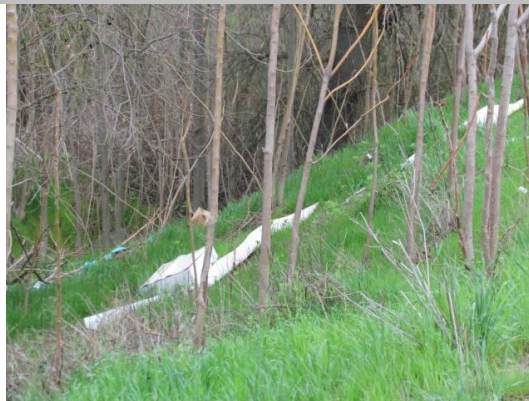
Photo 1 of 2 : SP_2015_RD0765_211_55_20150309_00057.jpg

Looking northwest at garbage on landside slope.

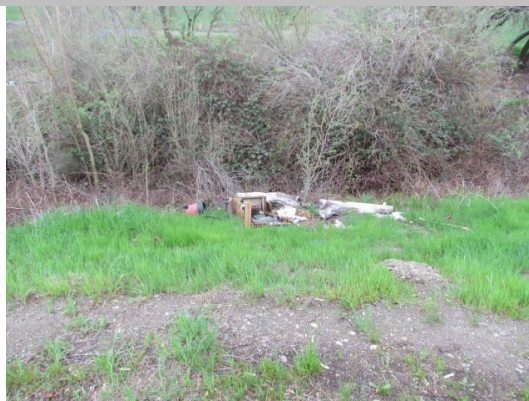
Photo 2 of 2 : SP_2015_RD0765_211_55_20150309_00058.jpg

Looking west at garbage on landside slope.

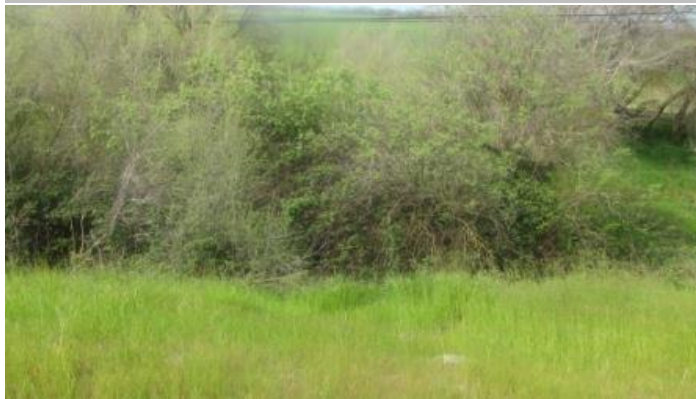
Photo 1 of 5 : SP_2015_RD0765_211_33_20150309_00037.jpg

Looking northwest at trees on landside toe from 2010 fall inspection.

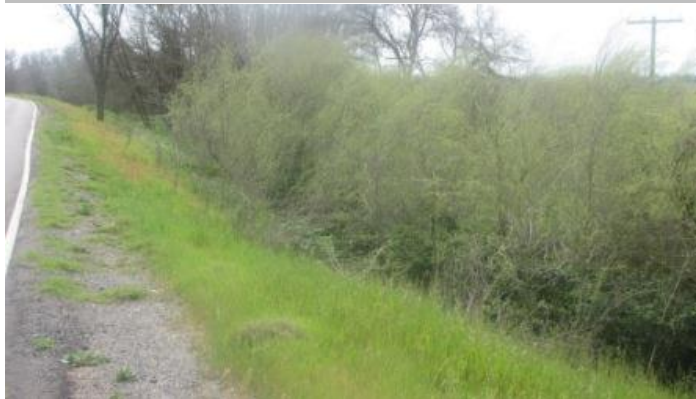
Photo 2 of 5 : SP_2015_RD0765_211_33_20150309_00038.jpg

Looking downstream (south) at trees on landside slope & toe.

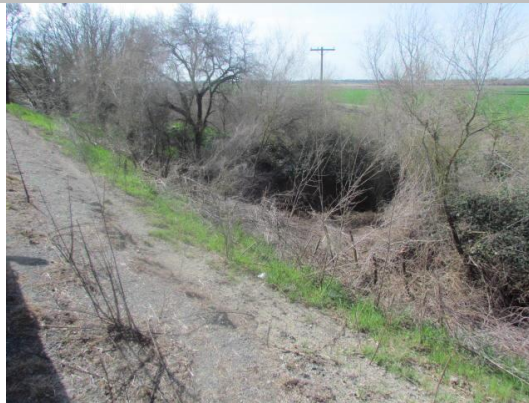
Photo 3 of 5 : SP_2015_RD0765_211_33_20150309_00039.jpg

Looking southwest at dense vegetation on landside slope and toe.

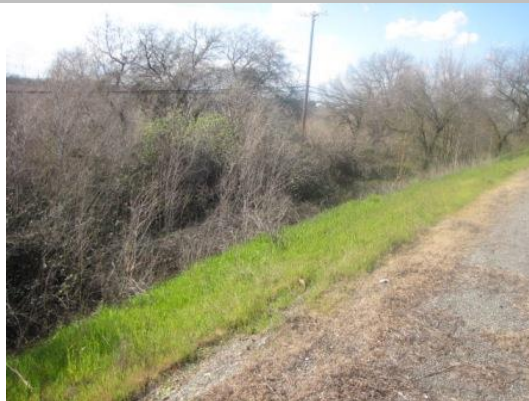
Photo 4 of 5 : SP_2015_RD0765_211_33_20150309_00040.jpg

Looking upstream (northwest) at dense vegetation on landside slope.

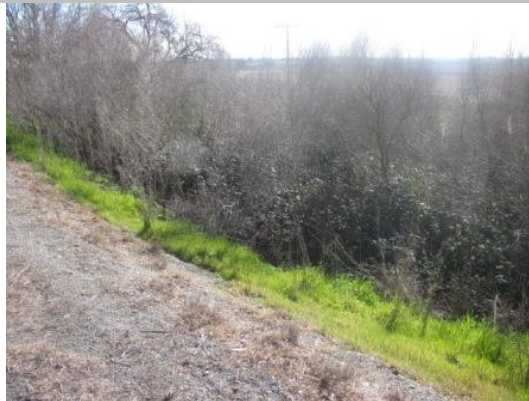
Photo 5 of 5 : SP_2015_RD0765_211_33_20150309_00041.jpg

Looking downstream (southwest) at dense vegetation on landside slope.

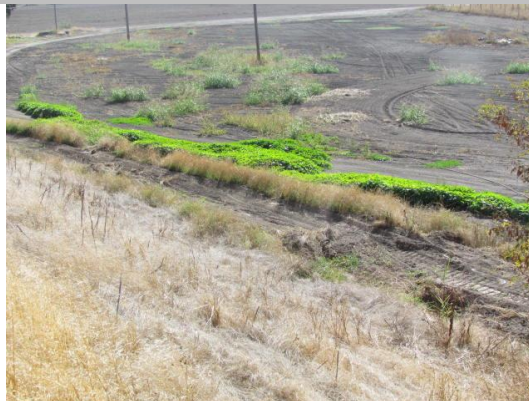
Photo 1 of 3 : SP_2015_RD0765_211_56_20150309_00059.jpg

Looking southwest at irrigation ditch filled in.

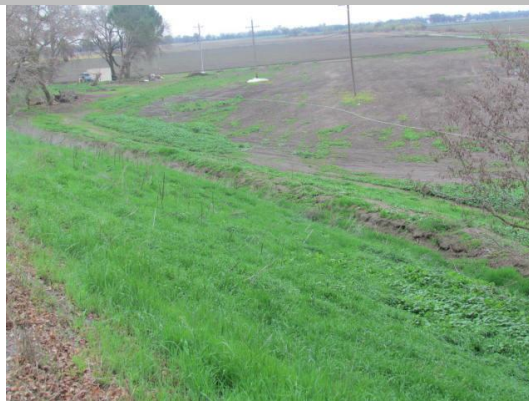
Photo 2 of 3 : SP_2015_RD0765_211_56_20150309_00060.jpg

Looking southwest at irrigation ditch running along landward toe.

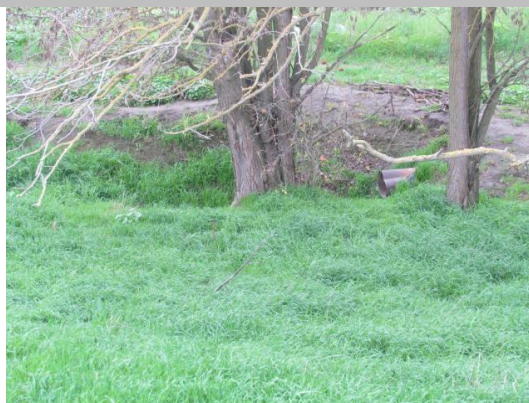
Photo 3 of 3 : SP_2015_RD0765_211_56_20150309_00061.jpg

Looking west at irrigation ditch at landward toe.

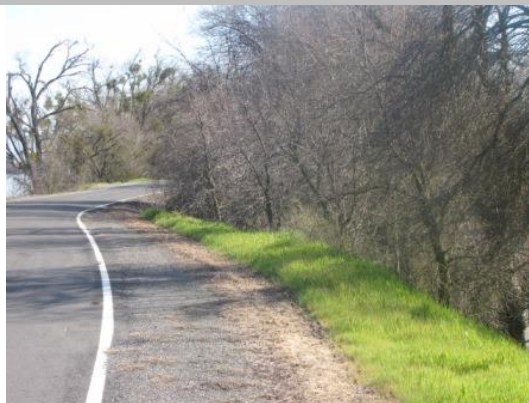
Photo 1 of 6 : SP_2015_RD0765_211_17_20150309_00019.jpg

Looking downstream (south) at dense trees on landside slope and toe.

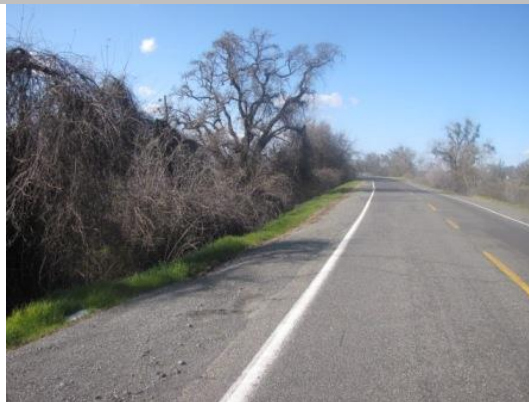
Photo 2 of 6 : SP_2015_RD0765_211_17_20150309_00020.jpg

Looking upstream (north) at dense trees on landside slope and toe.

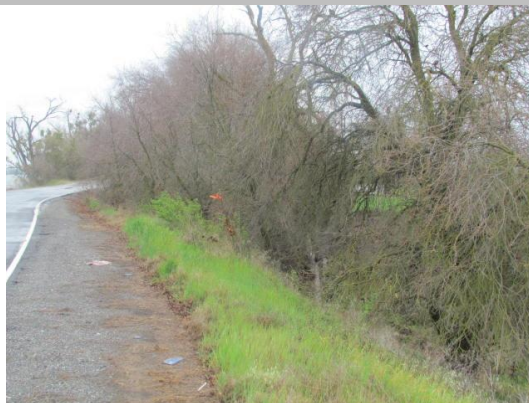
Photo 4 of 6 : SP_2015_RD0765_211_17_20150309_00022.jpg

Looking southwest at dense trees on landside slope and toe spring 2012.

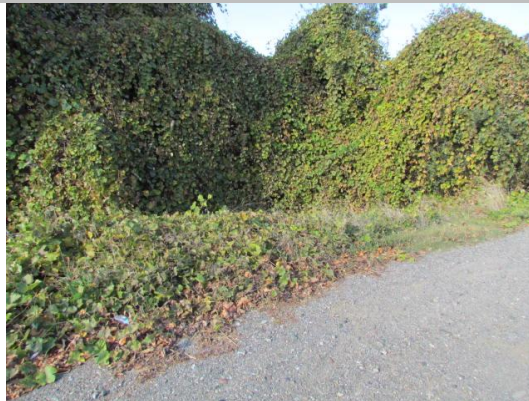
Photo 1 of 5 : SP_2015_RD0765_211_81_20150309_00064.jpg

Looking west at dense berryvines and wildroses on landside shoulder and slope. (November 2011)

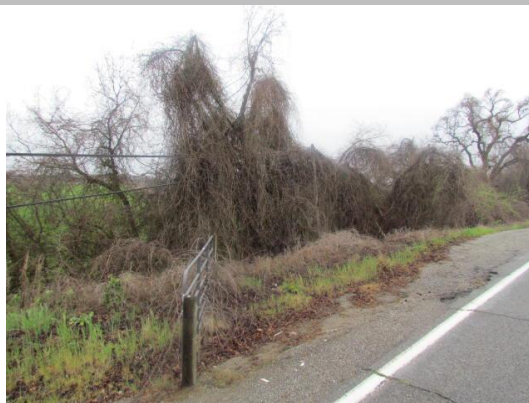
Photo 2 of 5 : SP_2015_RD0765_211_81_20150309_00065.jpg

Looking northwest at vines on landside toe spring 2012.

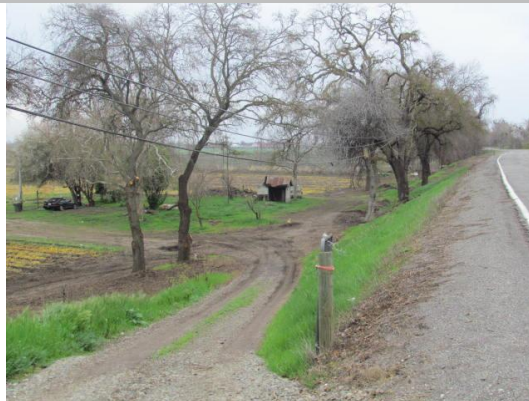
Photo 3 of 5 : SP_2015_RD0765_211_81_20150309_00066.jpg

Looking northwest at trimmed trees and vegetation on landside slope and toe.

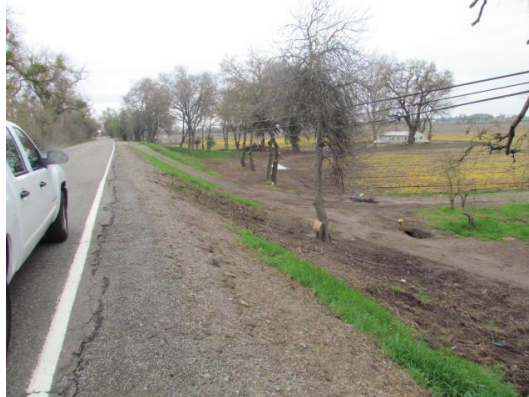
Photo 4 of 5 : SP_2015_RD0765_211_81_20150309_00067.jpg

Looking southwest at trimmed trees and vegetation on landside slope and toe.

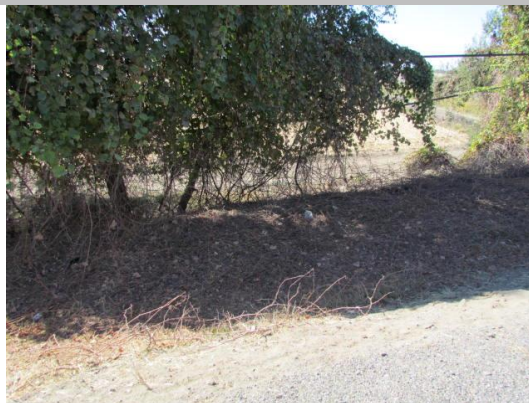
Photo 5 of 5 : SP_2015_RD0765_211_81_20150309_00068.jpg

Looking west at trimmed trees on landward slope.

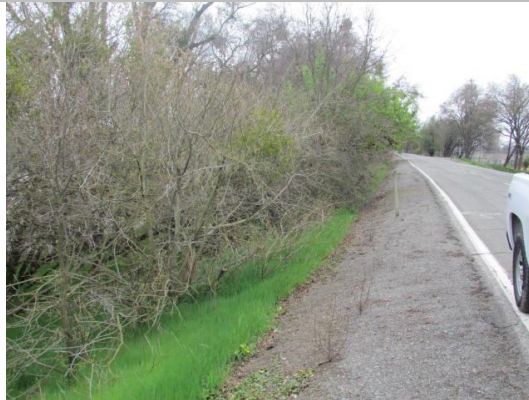
Photo 1 of 2 : SP_2015_RD0765_211_6_20150309_00007.jpg

Looking south (downstream) at untrimmed trees on waterward slope.

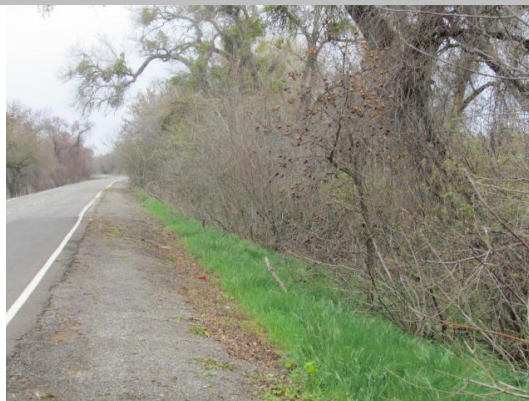
Photo 2 of 2 : SP_2015_RD0765_211_6_20150309_00008.jpg

Looking north (upstream) at untrimmed trees on waterward slope.

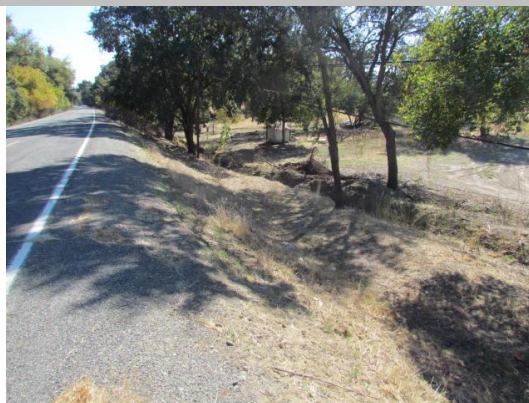
Photo 1 of 1 : SP_2015_RD0765_211_51_20150309_00052.jpg

Looking southwest at irrigation ditch on landward toe.

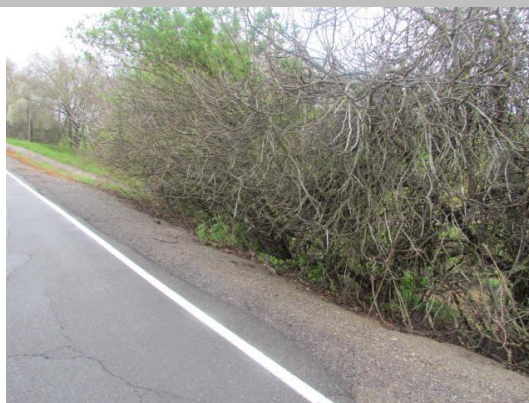
Photo 1 of 1 : SP_2015_RD0765_211_40_20150309_00046.jpg

Looking southwest at fig trees and other trees on landside slope and toe.

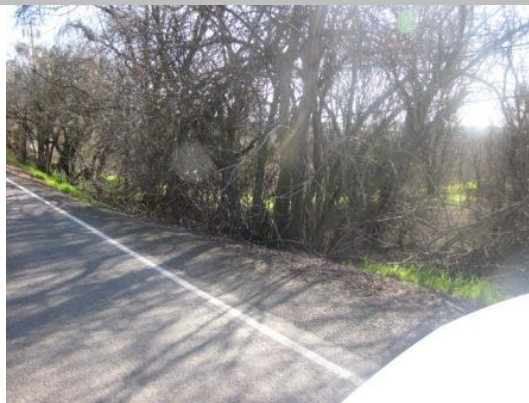
Photo 3 of 4 : SP_2015_RD0765_211_37_20150309_00044.jpg

Looking downstream (southwest) at dense trees on landside slope and toe.

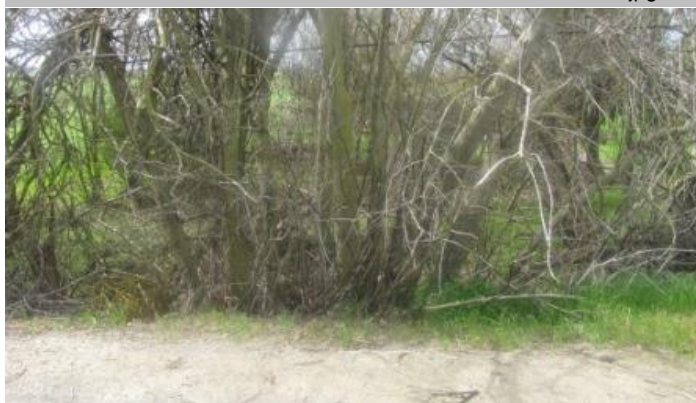
Photo 4 of 4 : SP_2015_RD0765_211_37_20150309_00045.jpg

Looking west at trees on landside slope & toe.

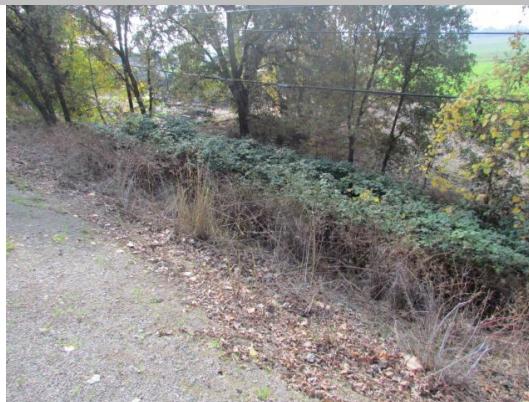
Photo 1 of 1 : SP_2015_RD0765_211_48_20150309_00049.jpg

Looking southwest at dense vegetation on landside slope and toe.

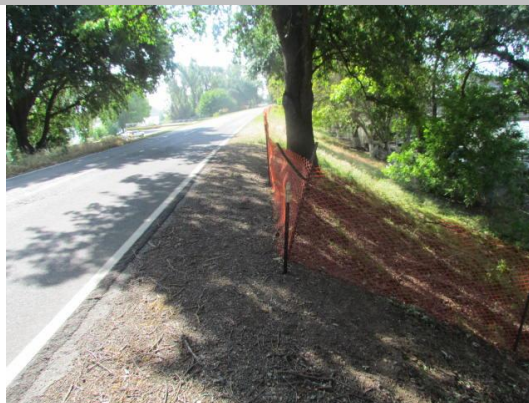
Photo 1 of 2 : SP_2015_RD0765_211_54_20150424_00069.jpg

Looking south at temporary fence on landward slope.

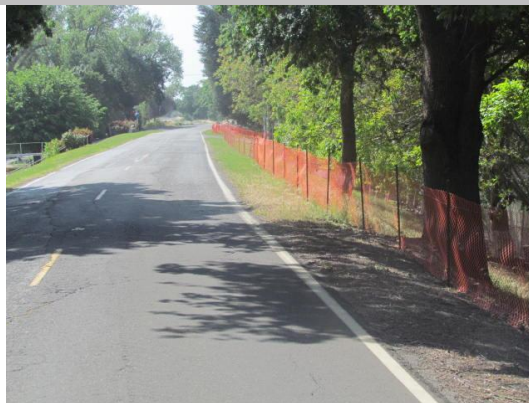
Photo 2 of 2 : SP_2015_RD0765_211_54_20150424_00070.jpg

Looking south at temporary fence on landward shoulder.

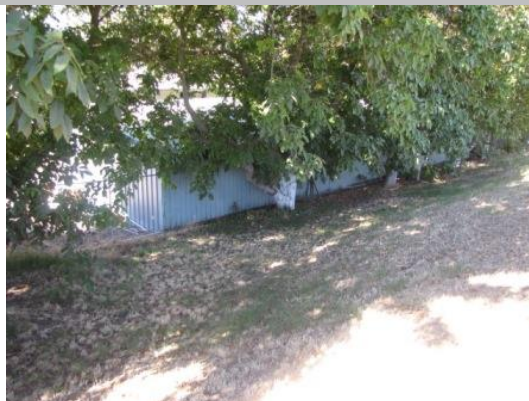
Photo 1 of 1 : SP_2015_RD0765_211_43_20150309_00047.jpg

Looking northwest at buildings along landside toe.

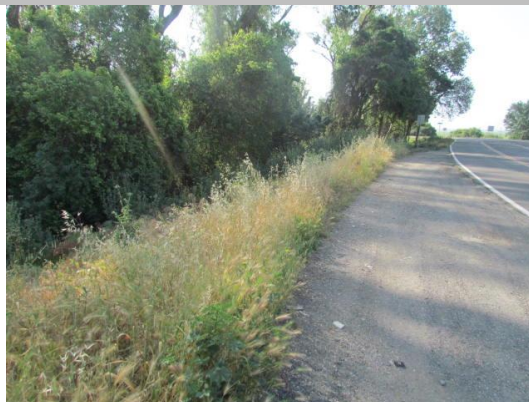
Photo 1 of 1 : SP_2015_RD0765_211_1_20150424_00071.jpg

Looking southeast at dense vegetation on waterward slope.

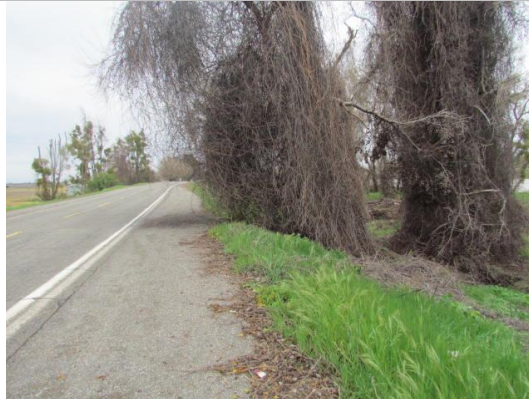
Photo 1 of 1 : SP_2015_RD0765_211_4_20150309_00004.jpg

Looking north at untrimmed trees on waterward slope.

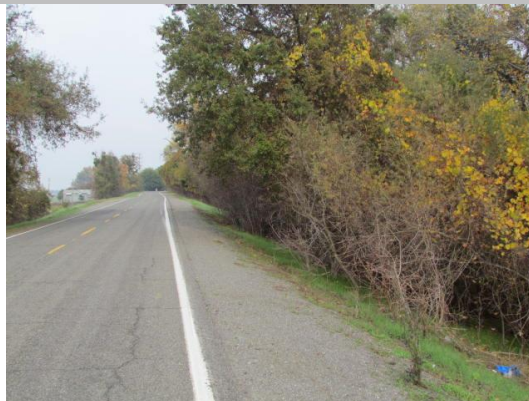
Photo 1 of 2 : SP_2015_RD0765_211_5_20150309_00005.jpg

Looking north at dense vegetation on waterside slope. (Fall Inspection 2012)

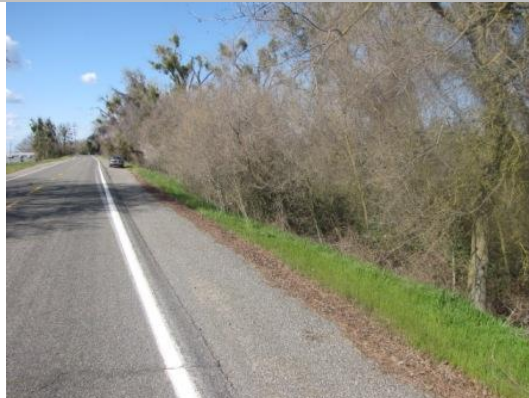
Photo 2 of 2 : SP_2015_RD0765_211_5_20150309_00006.jpg

Looking upstream (north) at dense trees on waterside slope.

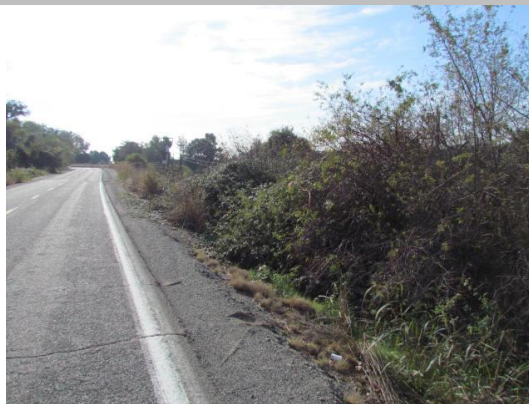
Photo 1 of 6 : SP_2015_RD0765_211_29_20150309_00030.jpg

Looking south at dense vegetation on landside shoulder and slope.
(November 2011)

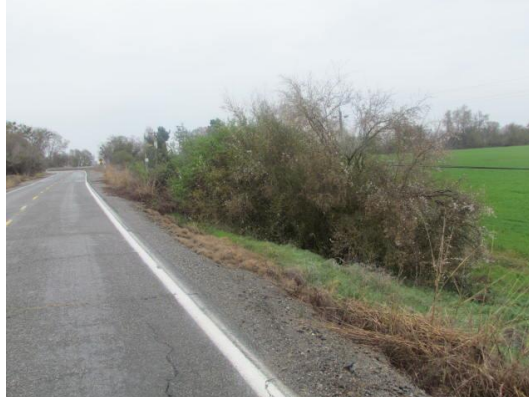
Photo 2 of 6 : SP_2015_RD0765_211_29_20150309_00031.jpg

Looking south at dense vegetation on landside slope and toe spring 2012.

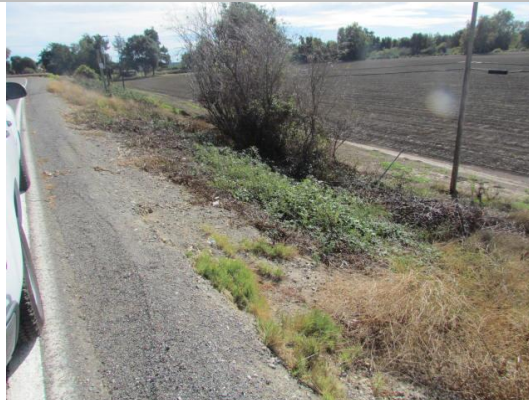
Photo 3 of 6 : SP_2015_RD0765_211_29_20150309_00032.jpg

Looking south at moderate vegetation on landward slope and toe. (Fall 2014)

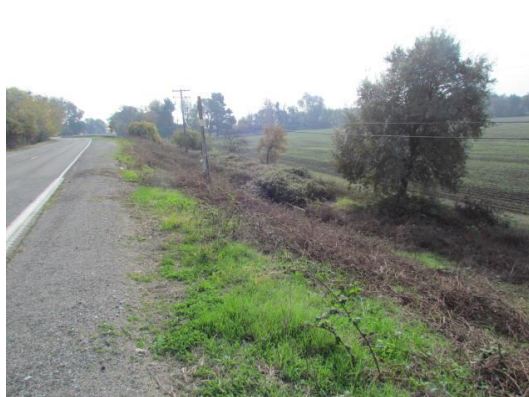
Photo 4 of 6 : SP_2015_RD0765_211_29_20150309_00033.jpg

Looking southwest at vegetation on landside slope and toe. (Fall Inspection 2012)

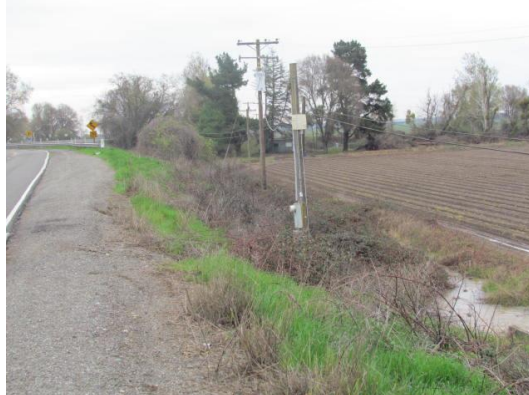
Photo 5 of 6 : SP_2015_RD0765_211_29_20150309_00034.jpg

Looking southwest at berryvines on landside slope.

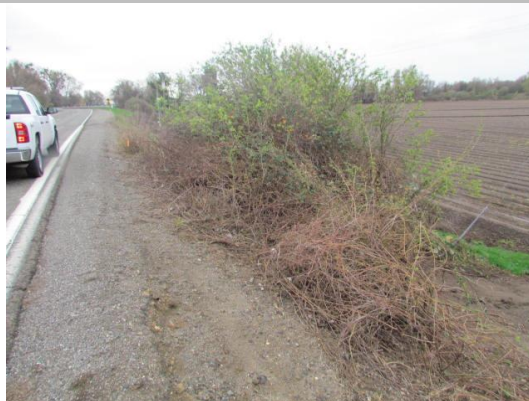
Photo 6 of 6 : SP_2015_RD0765_211_29_20150309_00035.jpg

Looking southwest at vegetation on landside slope.

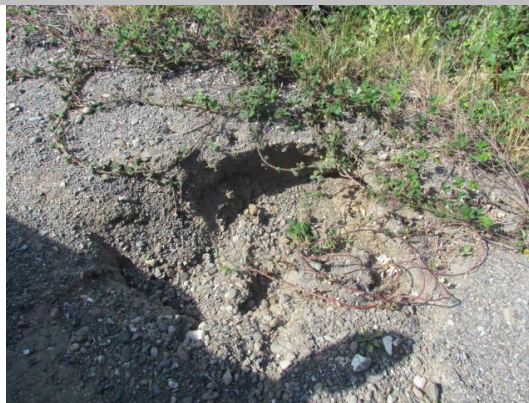
Photo 1 of 2 : SP_2015_RD0765_211_57_20150424_00073.jpg

Looking east at caving on landward shoulder.

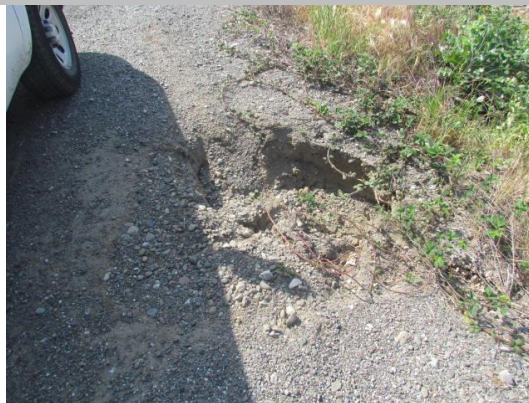
Photo 2 of 2 : SP_2015_RD0765_211_57_20150424_00074.jpg

Looking south at caving on landward shoulder.

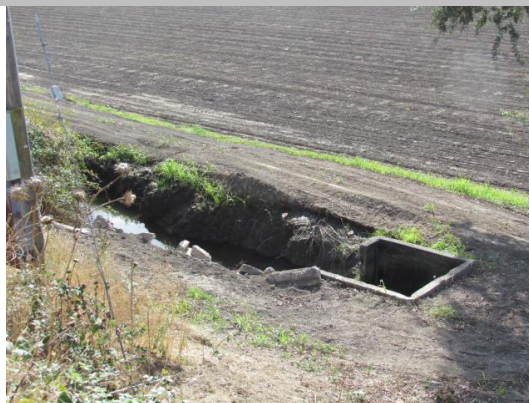
Photo 1 of 2 : SP_2015_RD0765_211_60_20150309_00062.jpg

Looking southwest at irrigation ditch at landward toe. (Fall 2014)

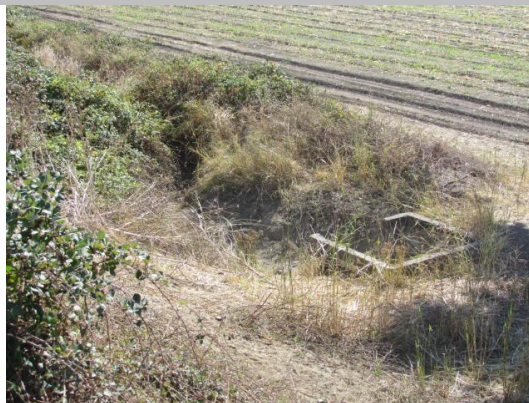
Photo 2 of 2 : SP_2015_RD0765_211_60_20150309_00063.jpg

Looking southwest at irrigation ditch on landward toe.

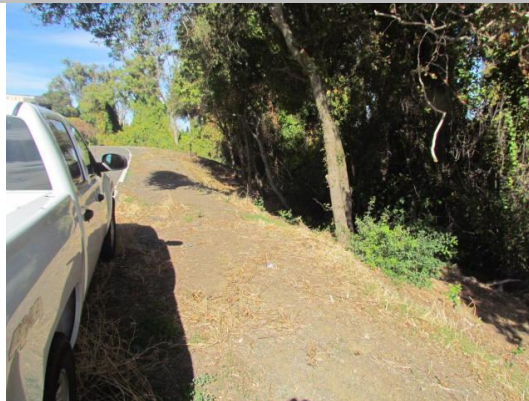
Photo 1 of 2 : SP_2015_RD0765_211_52_20150309_00053.jpg

Looking north (upstream) at trimmed trees on landward slope. (Fall 2014)
